TEST OF AN AERODYNAMICALLY HEATED MULTIWEB WING

STRUCTURE (MW-1) IN A FREE JET

AT MACH NUMBER 2

NATIONAL ADVISORY COMMITTEE  
FOR AERONAUTICS

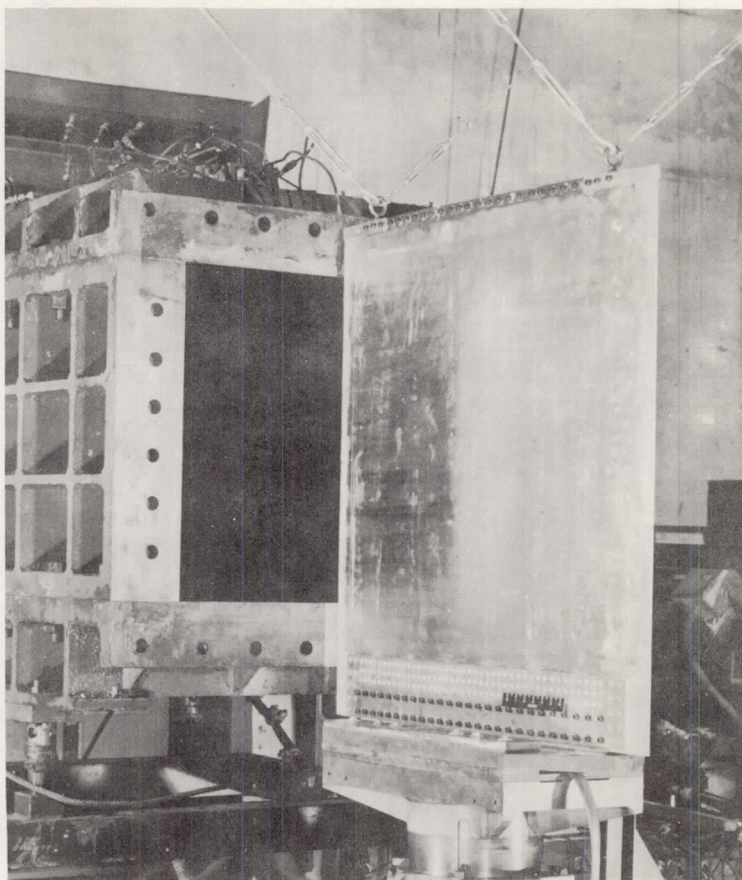
Figure 3.- Model in place at nozzle exit prior to test.

The model was mounted vertically in the jet at a nominal angle of attack of  $0^{\circ}$  and with its leading edge 1 inch downstream of the nozzle exit plane. (See figs. 2 and 3.) The model extended completely through the jet with the tip extending 4 inches above and the root 9 inches below the airstream. Thus, about two-thirds of the span was within the jet with the bulkheads and root connection being outside the jet. The top of the model was stabilized by guy cables attached near both the leading and trailing edges.

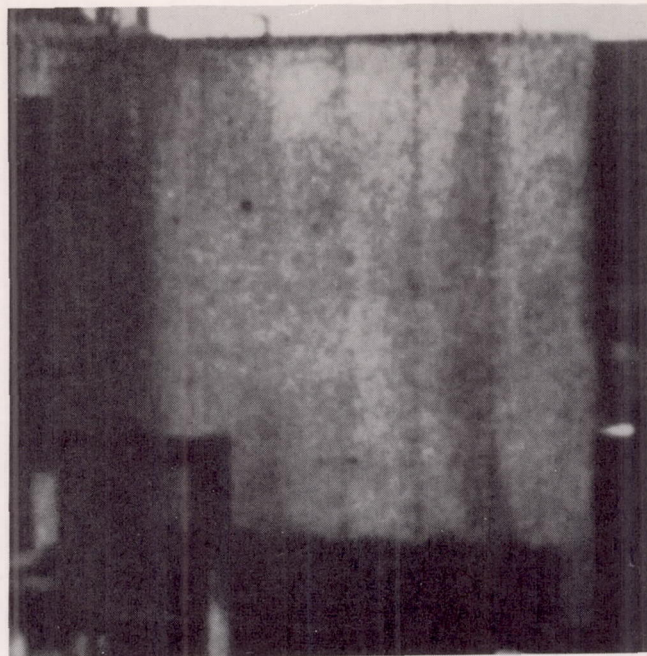
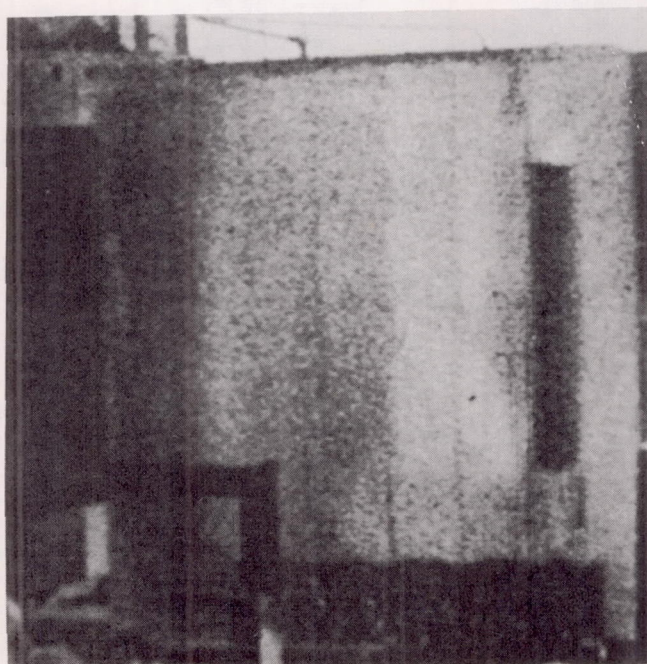
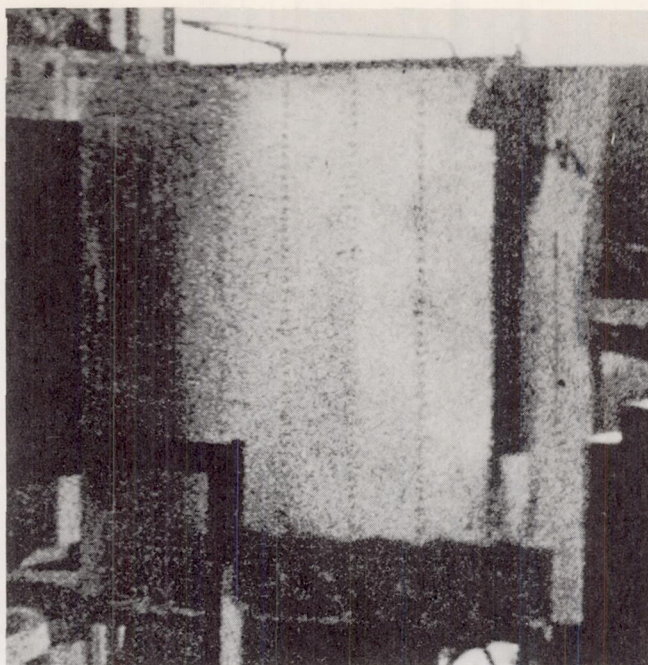
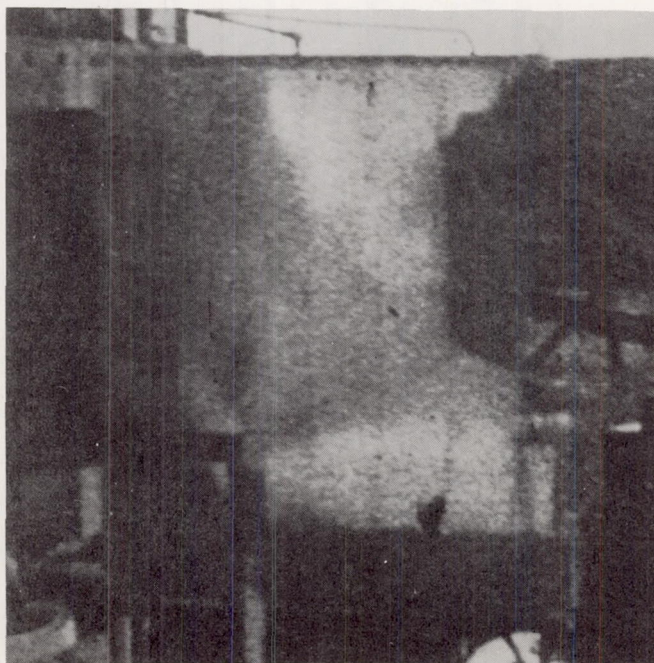
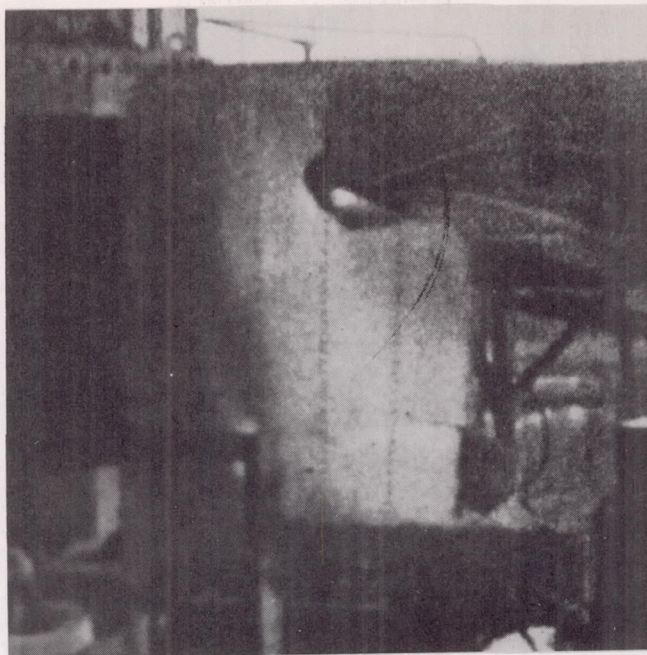
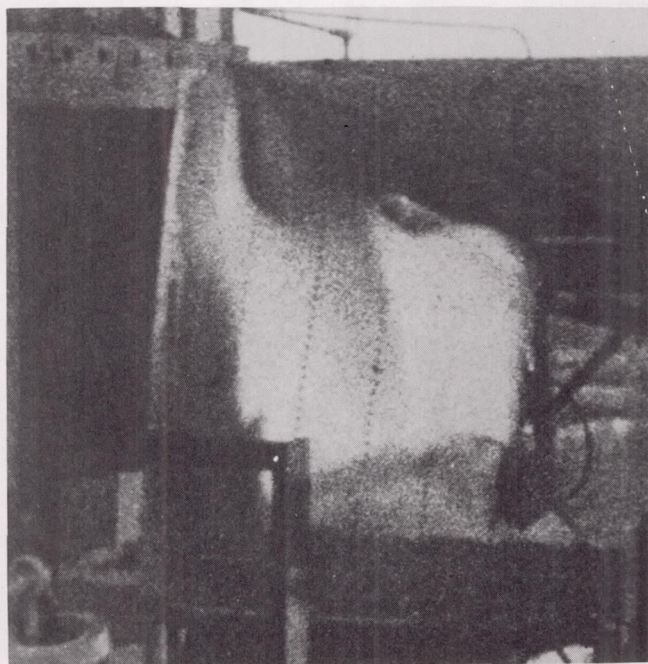
Figure 4.- Progressive failure of model (taken from motion picture).

of trouble was buckling of the skin panels near the leading edge. These buckles appeared and disappeared rapidly, moving toward the trailing edge. At 8.1 seconds, the cable guys at the top had shaken loose and a buckle had settled in the most rearward skin panel which then failed at about 8.8 seconds. The trailing-edge piece blew away at about 9.0 seconds and was followed by successive disintegration until complete destruction at about 9.9 seconds.

The process described is illustrated in figure 4 by six frames selected from the motion picture, and the remains of the model after the test are shown in figure 5. The times given in figure 4 and in the above description were obtained by correlating the movie with the recorders by means of the times at which the various thermocouples failed and should be considered approximate.

The failure was a dynamic phenomenon in that the buckling was not steady. The buckling started near the leading edge (the region of maximum heating) and then seemed to appear and disappear in several locations before settling in the most rearward panel. This latter buckle may not have been stationary despite the fact that the film so indicated, since the buckling frequency could have been such that the camera showed a stationary condition. Other vibrations were also in evidence for the guy cables at the top of the model were shaken loose, but no data are available to indicate the mode or frequency of such vibrations.

(a)  $t = 8.1$  sec. L-79266

(b)  $t = 8.8$  sec. L-79267

(c)  $t = 8.9$  sec. L-79268

(d)  $t = 9.2$  sec. L-79269

(e)  $t = 9.7$  sec. L-79270

(f)  $t = 9.8$  sec. L-79271

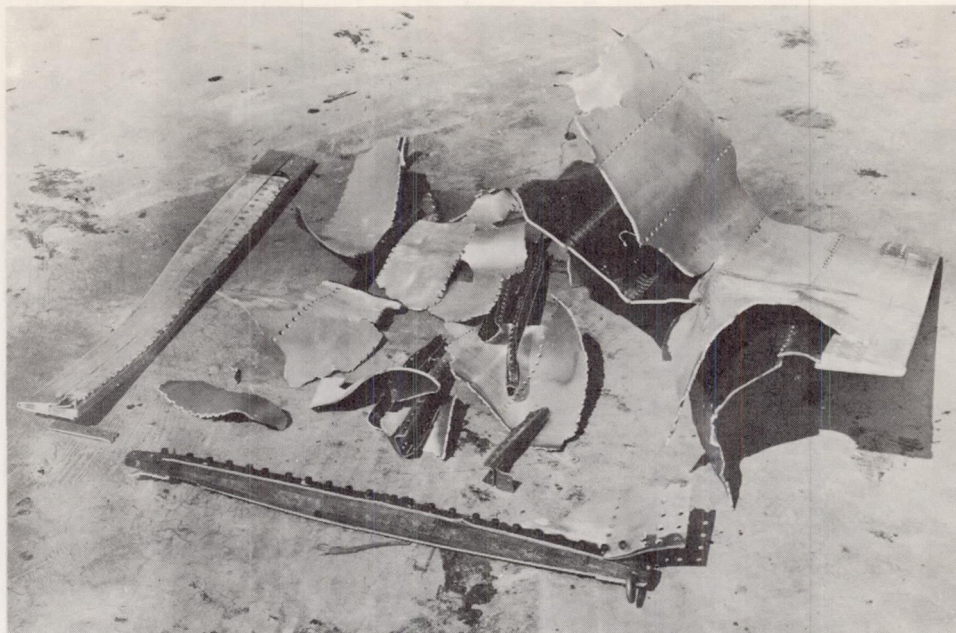
(a) Pieces separated during test.

Figure 5.- Remains of model after test.

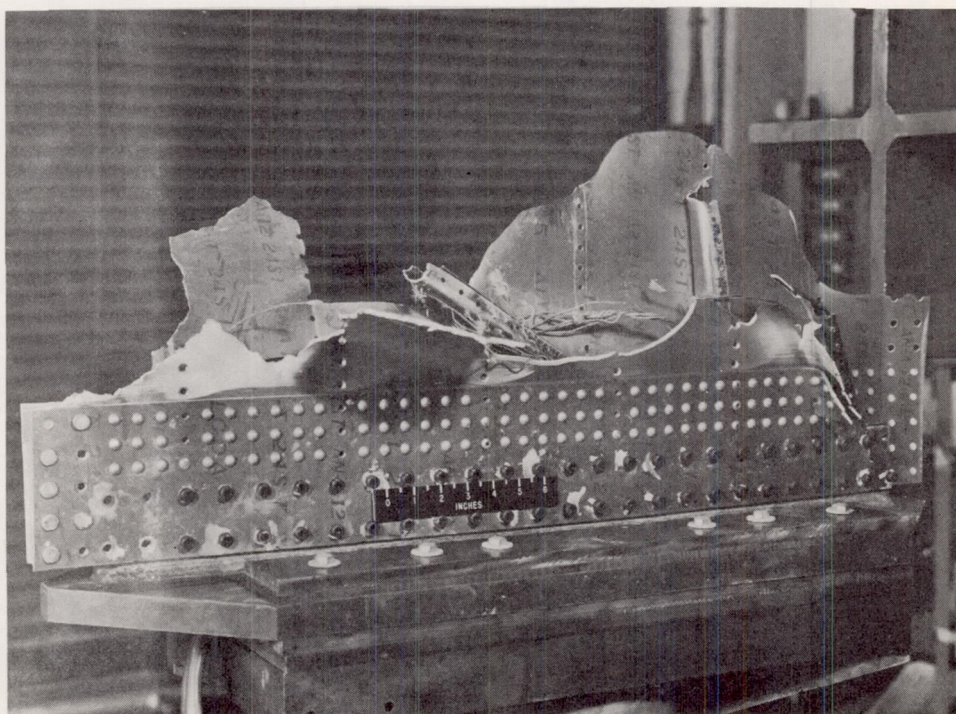
(b) Pieces attached to mounting fixture.

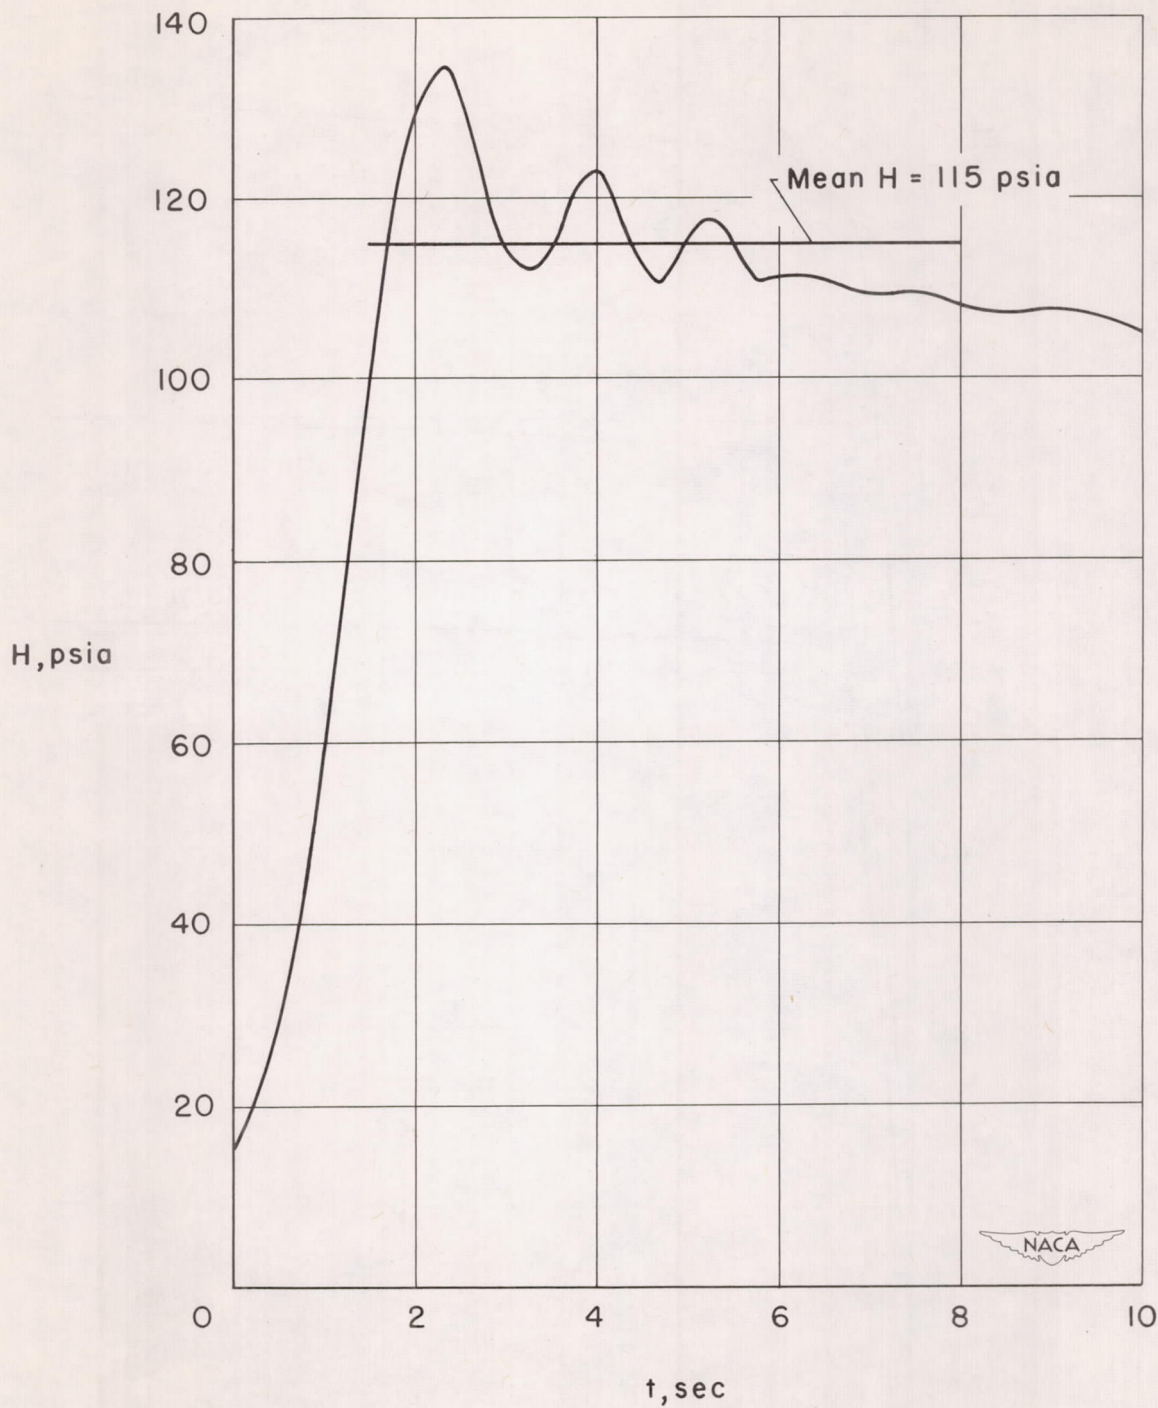
Figure 6.- Variation of stagnation pressure during test.

The variation of stagnation pressure with time is given in figure 6. Since the stagnation pressure fluctuated during the run, test conditions were never stabilized; however, an average value of the test stagnation pressure was determined by integrating the curve of  $H$  against  $t$  between  $t = 1.5$  and  $t = 8.0$  seconds.

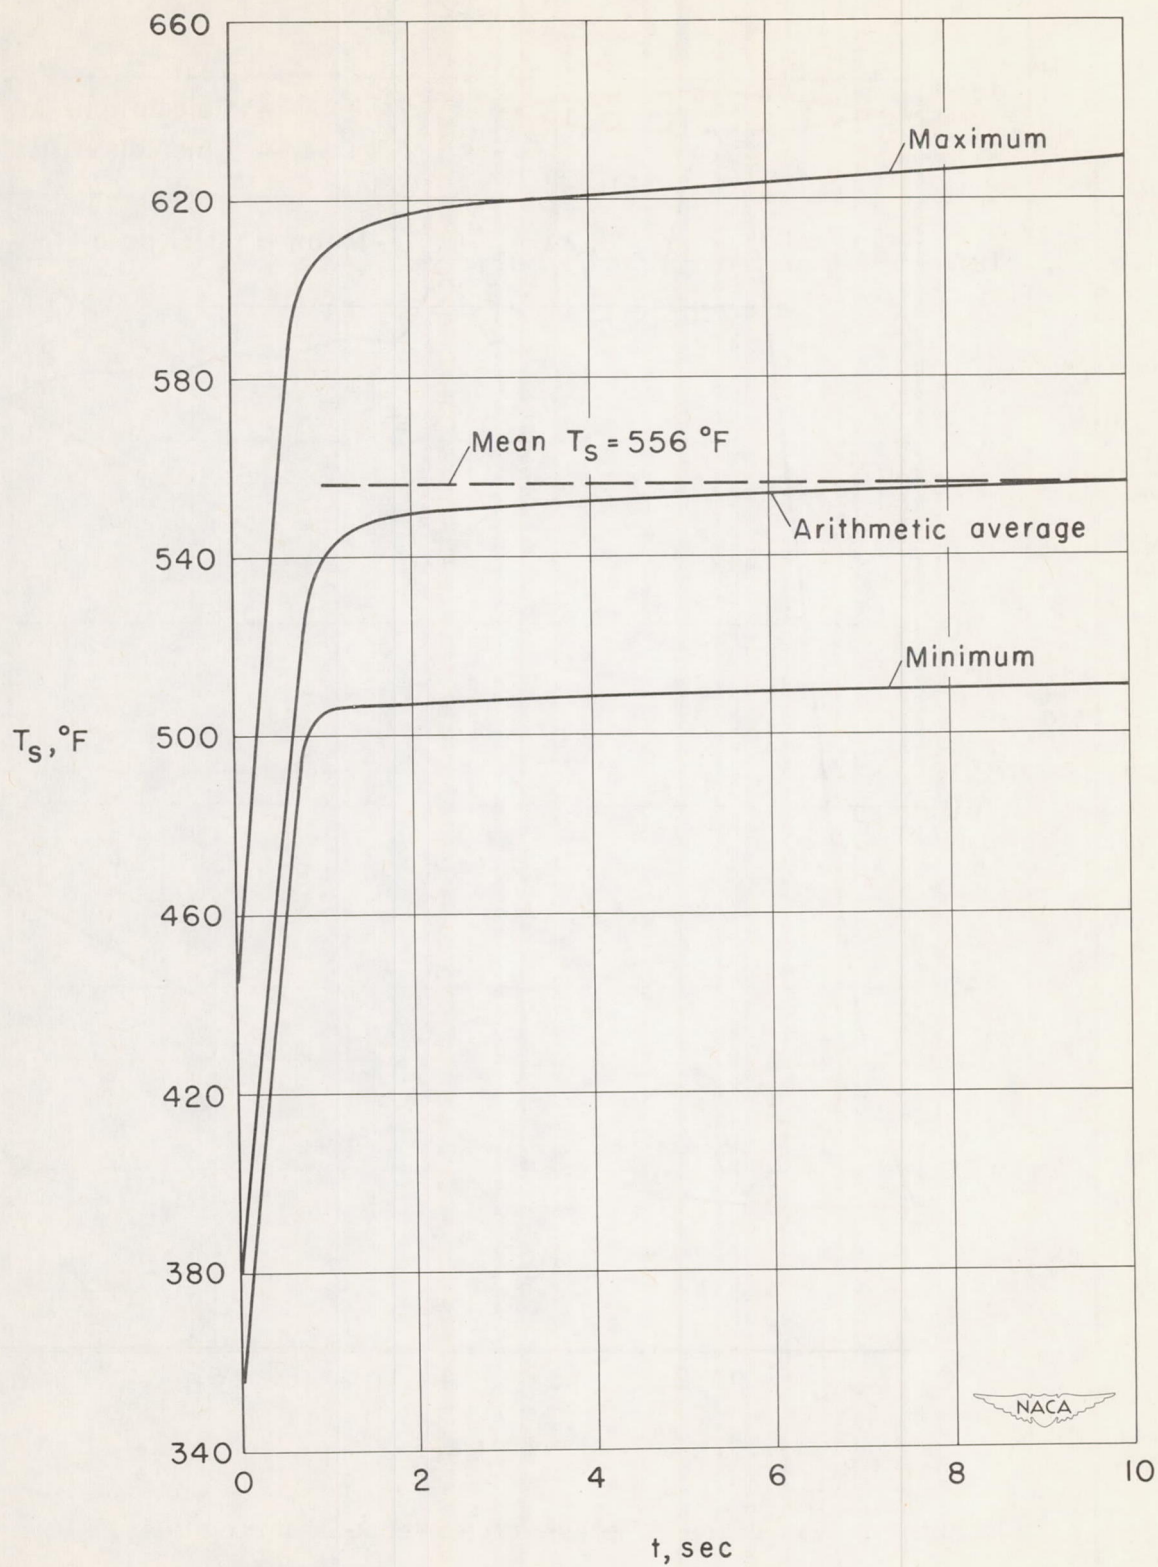
Figure 7.- Variation of stagnation temperature during test.

In figure 7, the stagnation-temperature curves show a time variation, but this variation is attributed to the relatively slow response of the stagnation thermocouples. A more unsatisfactory feature is the spread indicated by the stagnation thermocouples. The accuracy with which these thermocouples report the average stagnation temperature of the jet is unknown since no surveys have been made at the nozzle exit. For lack of better data, the arithmetic average of the individual stagnation thermocouples was used as the test stagnation temperature.

The poor agreement between theoretical and "indicated" adiabatic wall temperatures on the leading half of the chord, and thus recovery factors, may be partly due to the uncertainty involved in the determination of the average test stagnation temperature (see fig. 7). The "indicated" recovery factors obtained on the leading half of the model (0.68 to 0.76) are even lower than that expected in laminar flow, and laminar flow should not prevail on the model except near the leading edge because of the high

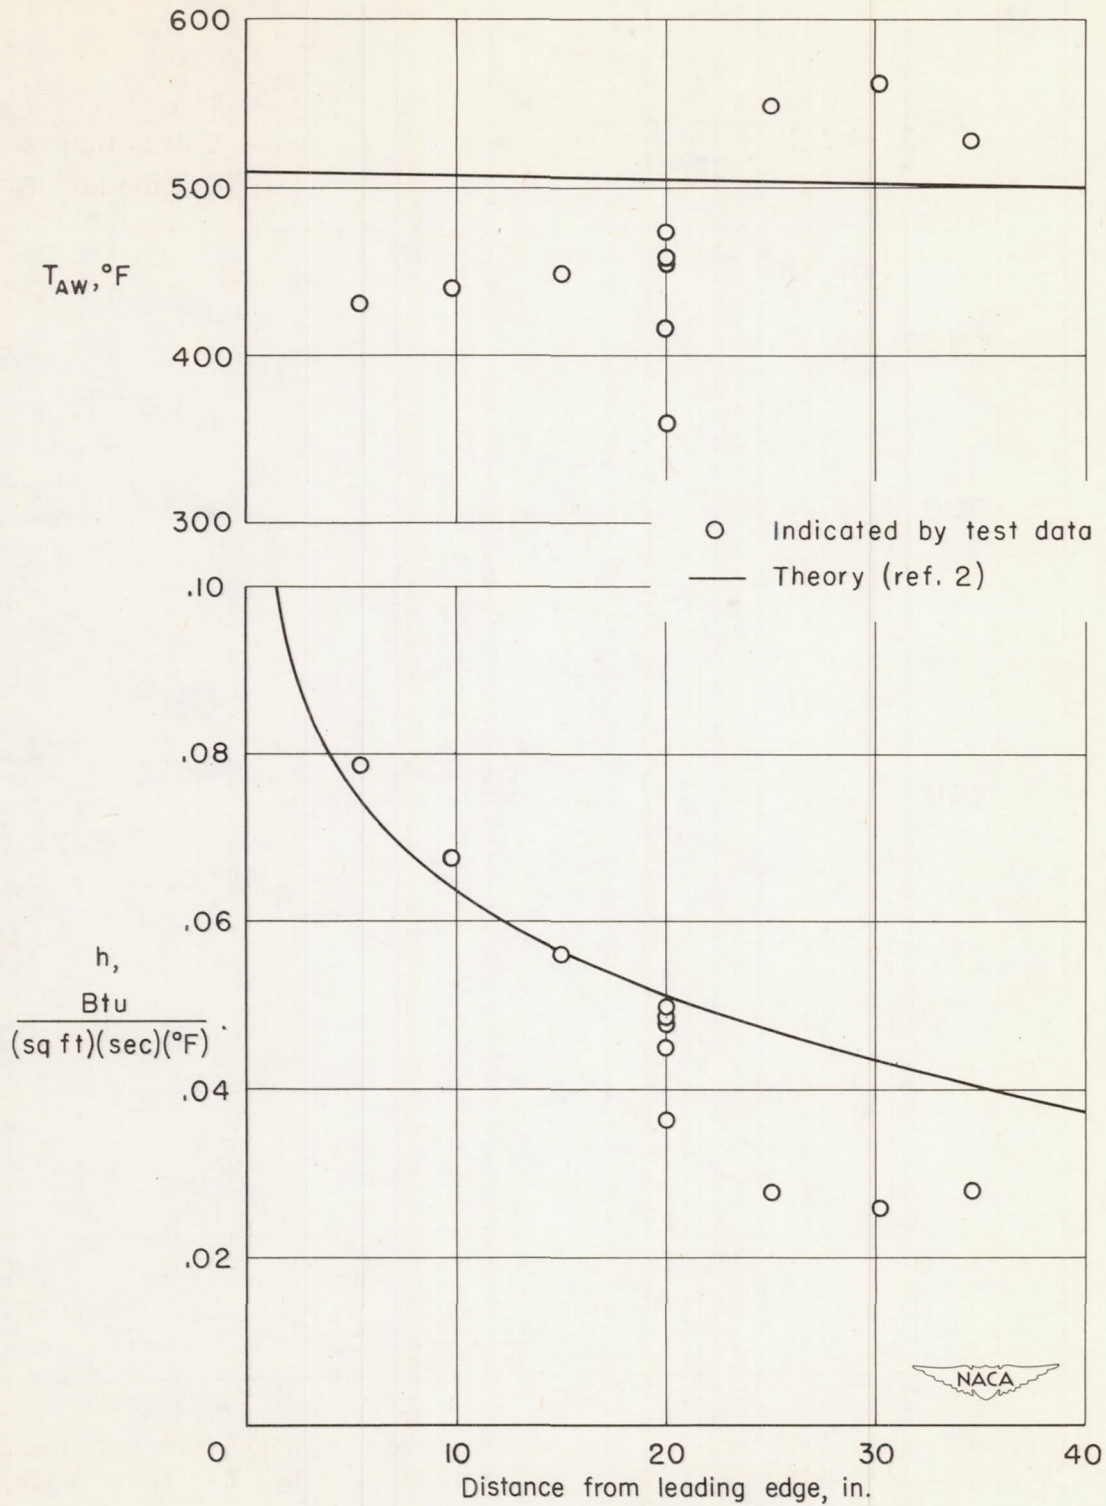
Figure 9.- Chordwise variation of adiabatic wall temperature and heat-transfer coefficient.

The heat-transfer coefficient  $h$  and adiabatic wall temperature  $T_{AW}$  were calculated from the turbulent-flow formulas given in reference 2 using parameters determined from local flow conditions just outside the boundary layer. Local flow conditions were calculated by a shock-expansion analysis of two-dimensional supersonic flow around a circular-arc airfoil in a uniform jet. The variation of stagnation pressure during the test had a negligible effect on the heat transfer except during the starting phase so that the starting phase was neglected and the average test conditions were used for the remainder of the test. The values thus obtained for  $h$  and  $T_{AW}$  vary across the chord of the model and are shown as the theoretical curve in figure 9.

The "indicated" heat-transfer coefficients agree well with the theoretical values on the leading half of the chord; whereas the agreement for the adiabatic wall temperatures is not so good. For both, the results are rather erratic in the trailing half, a result that can be attributed to the size of the model. The model was so large that the trailing half was in a region of nonuniform flow and thus the data in this region are somewhat questionable. This uncertainty is also reflected by plots of  $T$  against  $dT/dt$  for thermocouples 17, 19, and 21 in that they exhibited much more scatter than is shown in figure 10.

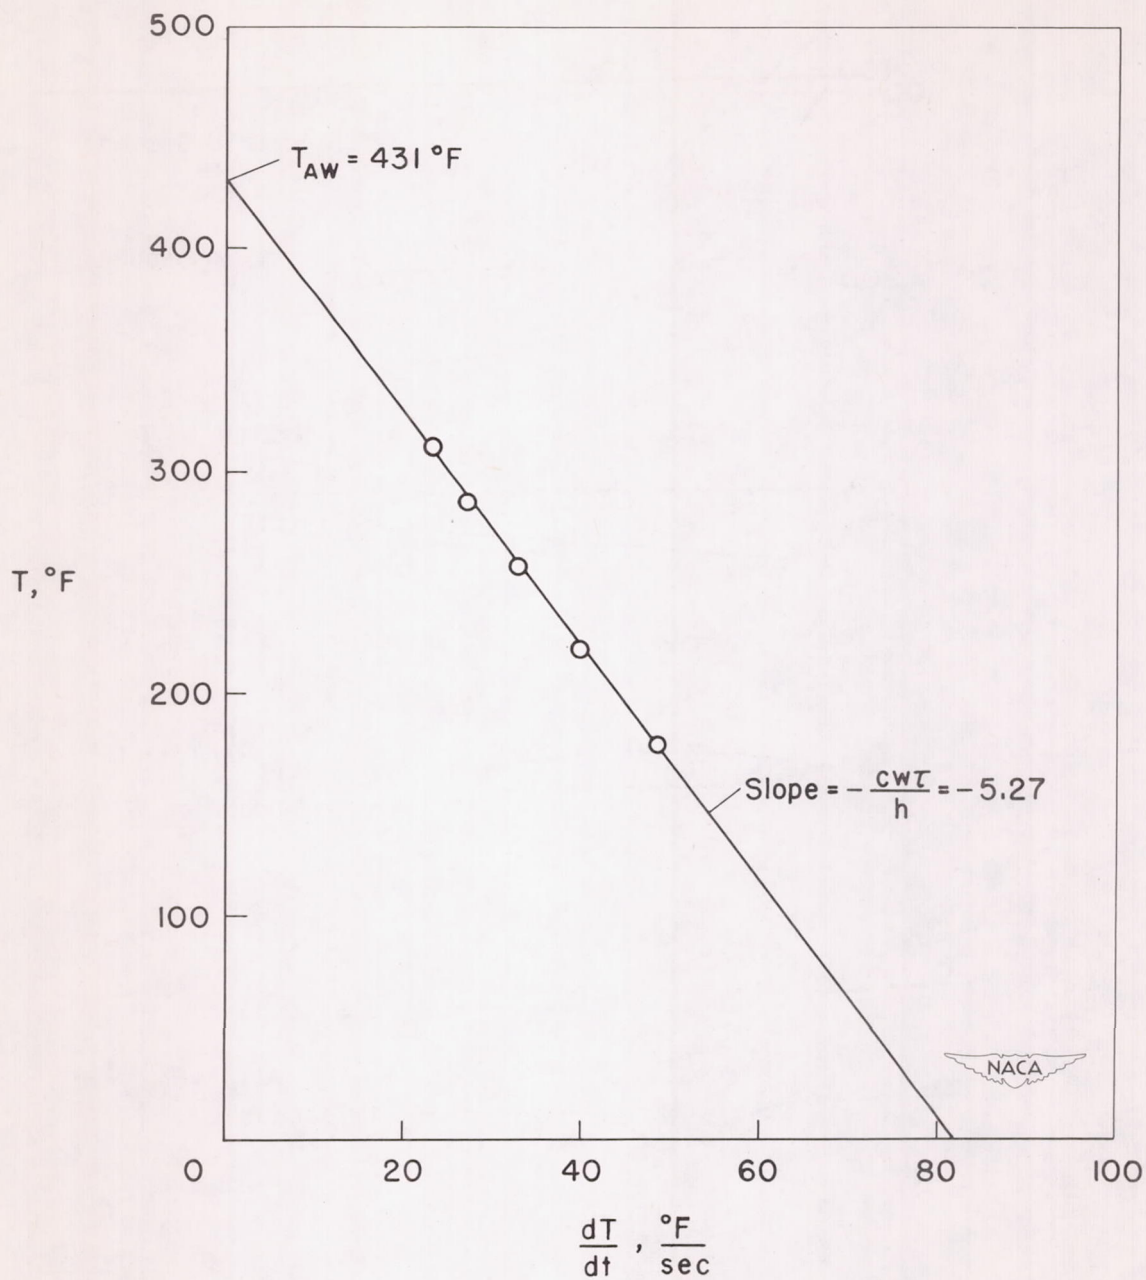
Figure 10.- Plot from which "indicated" values of adiabatic wall temperature and heat-transfer coefficient can be obtained for thermocouple 2.

Constant test conditions were nearly obtained, so the above method should be applicable to the experimental temperature histories. The data from all skin thermocouples, except 7 and 14 which may be influenced by heat conduction into the nearby web, were so analyzed by using the method of least squares to fit a straight line to the experimental points. Figure 10 is a sample plot of  $T$  against  $dT/dt$  and shows that the method is indeed applicable since the test points follow a straight line. The results of this analysis are plotted in figure 9, along with the theoretical values, as a function of distance from the leading edge. The group of points 20 inches from the leading edge give values obtained from the thermocouples (10, 11, 12, 13, and 15) distributed along the span of the model, but individual points have not been identified since there were no significant trends.
